# Significant Near Miss Involving a Fiberglass Extension Ladder

## Ladder Inspections - Why they are so Important

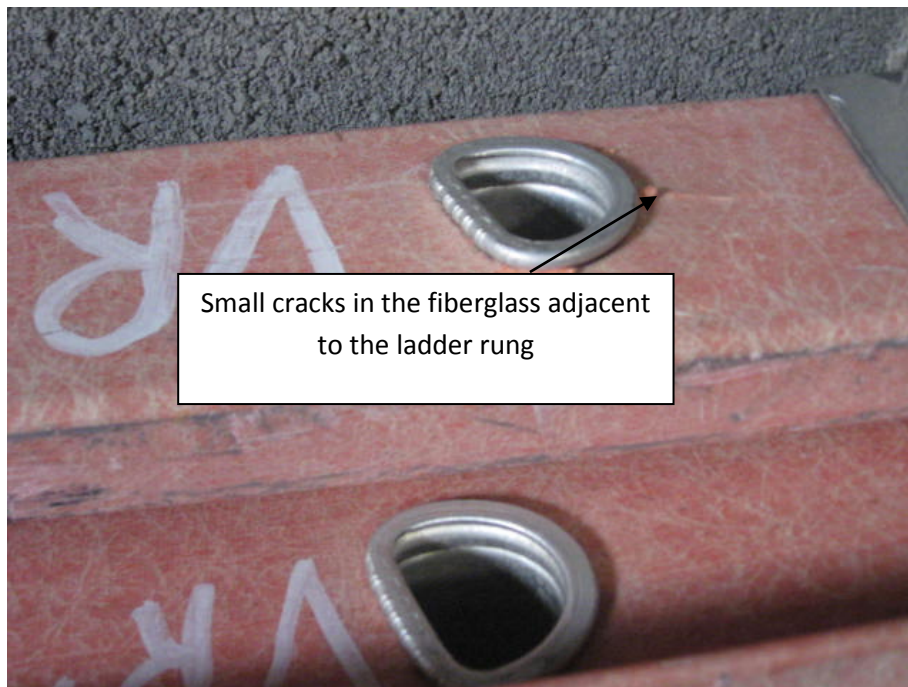
All fiberglass ladders were immediately brought in from the field and closely examined for any possible defects or damage. The company found that on approximately 20% of their fiberglass extension ladders there were very small cracks in the fiberglass on the siderails immediately next to the rungs of some ladders.

The small cracks found in the siderails of the extension ladders were not noted to be in any pattern along the siderail. The cracks and splits in the fiberglass were found to be immediately next to the rungs on the outside portion of the siderail.

Currently it is believed the fiberglass may have been damaged or fatigued during the manufacturing process when the rungs were crimped into the siderail of the ladder.

The small cracks around the rungs are not easily detected by a quick visual inspection. Workers need to 'feel' with their finger tips for any raised spots in the fiberglass and remove any debris along the side rails in the areas where the rungs are crimped to check for small cracks or splits. The cracks were not found in any pattern or specific location on all the ladders inspected. It is important to inspect each rung on both the exterior and interior side of the siderail for any signs of cracks or splits in the fiberglass.

Any fiberglass ladder with these small cracks should be removed from service.
